Chilika Lake (India) and Laguna de Bay (Philippines) Ecosystem Health Report Cards

Prepared by: Chilika Lake Development Authority, Laguna Lake Development Authority

Component D: Doc: D3-1

December 2018

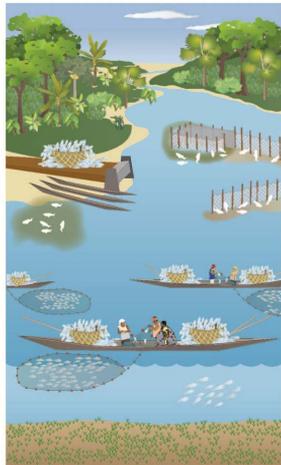
Fishing and Aquaculture

The recent abundance of fish stocks is not sustainable with overfishing and so many fishers. At landings, dead fish thrown back into the water contaminate the Lake. Active shrimp pens and abandoned nets trap sediment and kill juvenile fish.

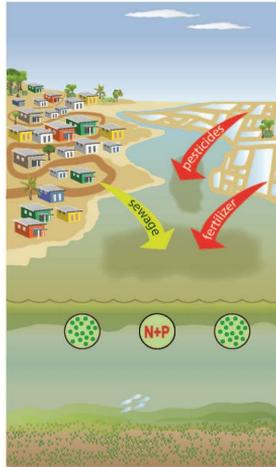
Pollution

As land use changes from forest to settlements and paddy agriculture, sewage, and fertilizer and pesticides runoff increases into the Lake. Algae blooms that float and sit on the bottom are the result of that extra nutrient input.

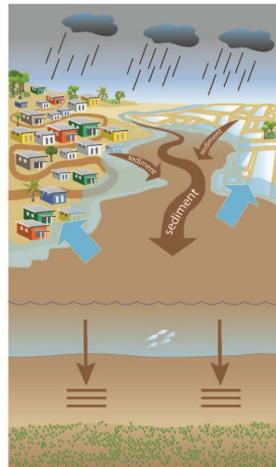
Sedimentation

During monsoon season, an excess of sediment is deposited in the Lake, mostly from Mahanadi River tributaries, nearby settlements, and agricultural lands. As the Lake becomes more shallow and its sea outlets fill in with sediment, increased flooding occurs.

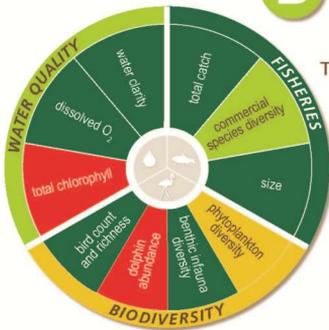
Northern Zone **B**

The Northern Zone displayed excellent results for fisheries, good water quality (with the exception of total chlorophyll), and average biodiversity largely due to an absence of dolphin sightings.

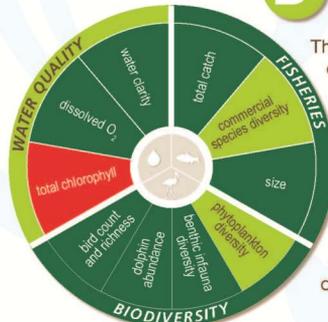
Central Zone **B+**

The Central Zone displayed excellent results for fisheries, good water quality (with the exception of total chlorophyll), and excellent biodiversity highlighted by bird count and richness, dolphin abundance, and benthic infauna diversity.

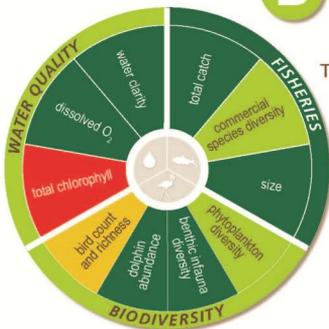
Southern Zone **B**

The Southern Zone displayed excellent results for fisheries, good water quality (with the exception of total chlorophyll), and good biodiversity highlighted by dolphin abundance and benthic infauna diversity.

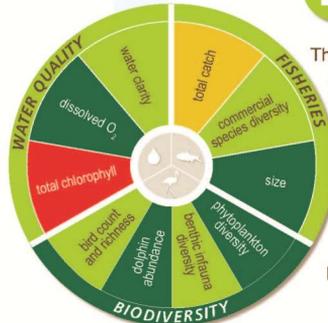
Outer Channel Zone **B**

The Outer Channel Zone displayed good results for fisheries and water quality (with the exception of total chlorophyll), and excellent biodiversity highlighted by excellent dolphin abundance and phytoplankton diversity.

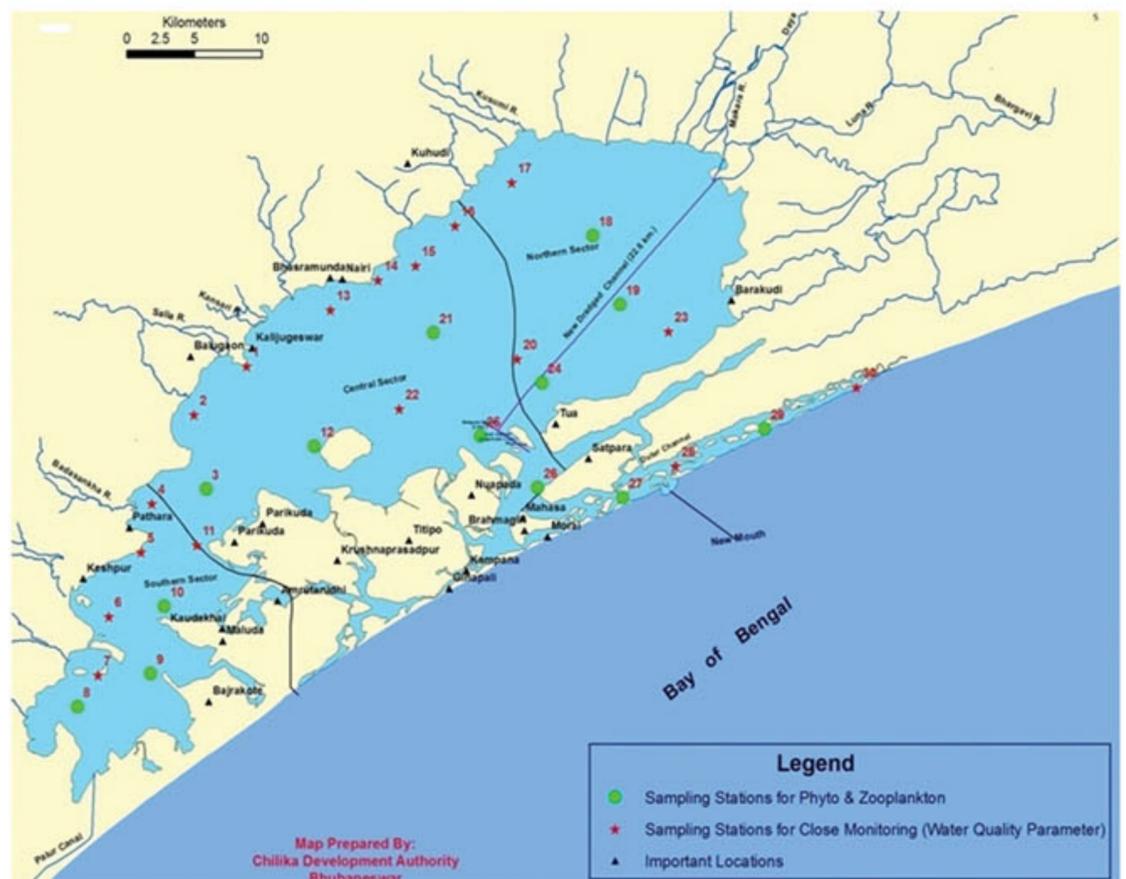
Sampling stations for water quality, phytoplankton, and benthos sample collection in Chilika Lake

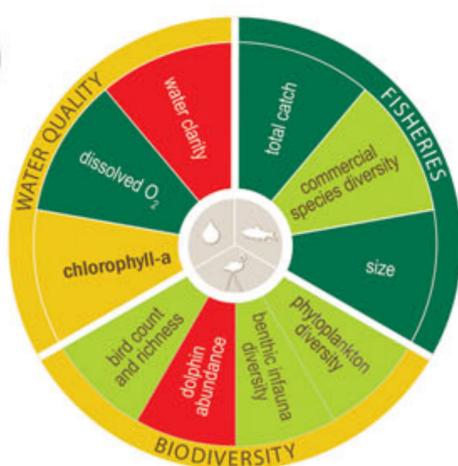
Northern Zone **B-**

The Northern zone displayed excellent results for fisheries, mix of good and poor level of water quality and biodiversity.

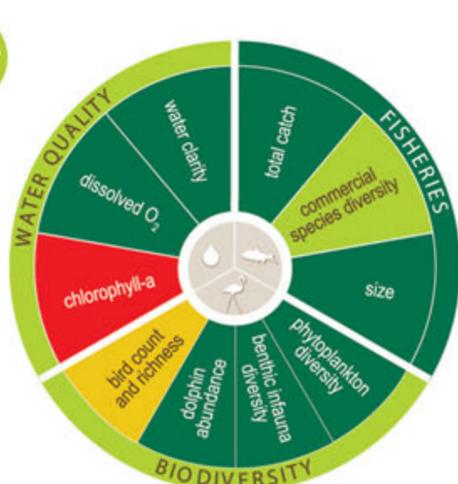
Southern Zone **B+**

The Southern zone displayed excellent results for fisheries, good water quality (with the exception of chlorophyll-a) and good biodiversity highlighted by dolphin abundance, macro-benthic faunal diversity and phytoplankton diversity.

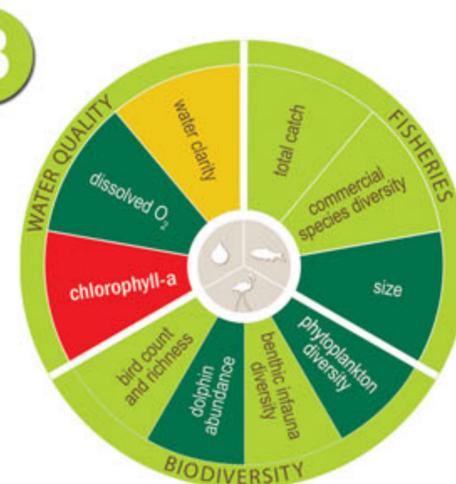
Outer Channel Zone **B**

The Outer channel zone displayed good results for fisheries, good water quality (with the exception of chlorophyll-a) and good biodiversity highlighted by excellent dolphin abundance, benthos and phytoplankton diversity.

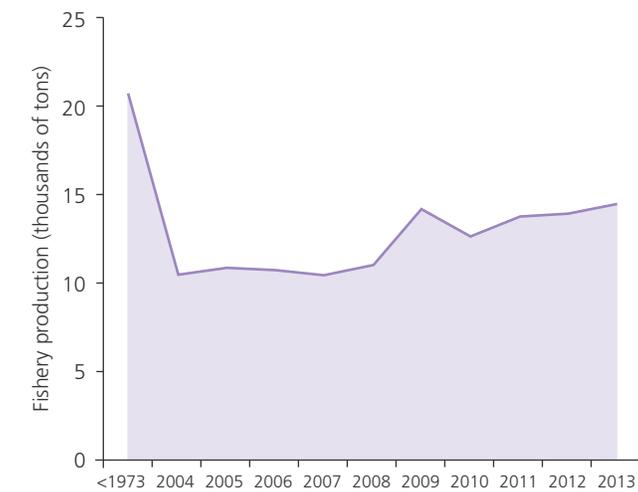
Ten year production trend in Laguna de Bay. Data source: Bureau of Agricultural Statistics.

Fisheries production prior to the introduction of fish pens in 1973 was at 20,700 T/yr. Catch data in 1995 was at 8,146 T/yr before the reported sightings of invasive species. In 1996, catch was at 3,055 T/yr when there were two strong typhoons and catch data were most likely from natural recruitment.

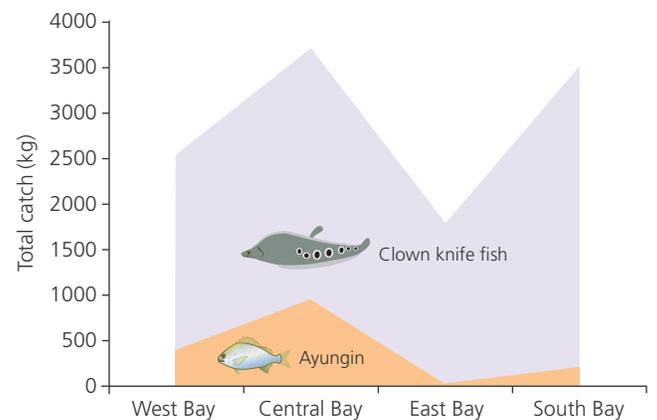
Comparison of clown knife fish and ayungin catch from actual sampling in Laguna de Bay in 2013. Data source: Bureau of Fisheries and Aquatic Resources

One of the most important native fishes in the Lake is the ayungin (*Leipotherapon plumbeus*). The highest total catch in 2013 is in the Central Bay, while the lowest is in the East Bay. This can be attributed to the high concentration of the invasive clown knife fish (*Notopterus chitala*) in the East Bay, which prey on ayungin. Clown knife fish eggs also attach to cultured fish cages and pens and once hatched, will feed on the fry and fingerlings of big head carp and bangus. The proliferation of knife fish has caused significant declines in cultured and native fish production.

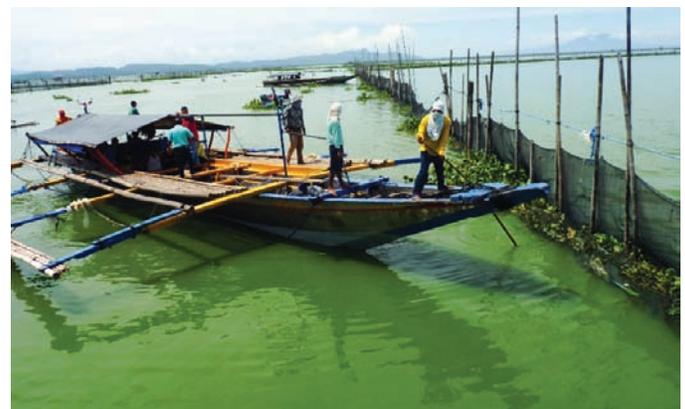
Algal bloom in tilapia fish pens. Photo: Mark Anthony Salvador

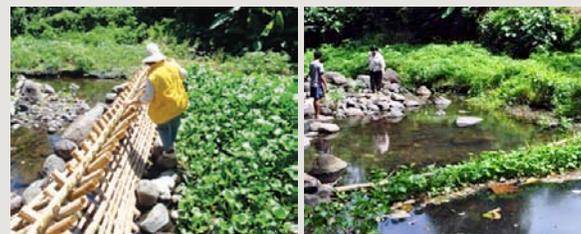
Molawin Creek is declared a biopark as water quality improves by the AMBS. Photos: Dr. Macrina Zafaralla (Los Baños Times)

The AMBS system is made of bamboo and water hyacinth (*Eichhornia crassipes*) or kang kong (*Ipomoea aquatica*). Initial data showed visible evidence of habitat restoration, i.e., clearer water after filtration and robust populations of native fish fingerlings in 1–2 weeks. Stream cleanup before installation is needed, thus requiring community cooperation.
