BMP Case Study

Name: Riparian Buffer Strips Perform Well in Iowa Study

Location/Terrain: Bear Creek, Story County, Iowa

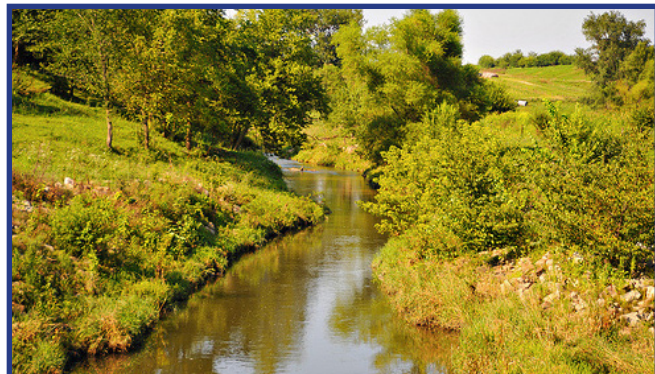
A saturated buffer was installed to catch tile line water before it is released into waterways. The system uses a shallow lateral line with control structures that raise the water table and slow outflow, allowing the buffers to naturally remove nutrients such as nitrate and phosphorous.
